Evaluating the Seismic Preparedness of New Mexico

The State of New Mexico does not currently have a comprehensive database of facilities such as fire stations, Emergency Operations Centers, hospitals, and other structures aiding in the recovery process following an earthquake or other natural disaster. Therefore, as a first step to ensure emergency preparedness of the state, this project aims to perform a seismic assessment of essential facilities in New Mexico. The research team initially considered facilities located in the Belen to Taos corridor, an area considered vulnerable to seismic incidents, as shown in Figure 1. The Federal Emergency Management Agency's (FEMA) Rapid Visual Screening (RVS) Method was used as the primary method to assess the seismic vulnerability of essential structures. This study represents the first phase of a multiphase earthquake assessment. In this phase, structures thought to be seismically hazardous are identified and prioritized. In following phases, the identified structures are assessed by a structural specialist to determine if they are, in fact, seismically hazardous.

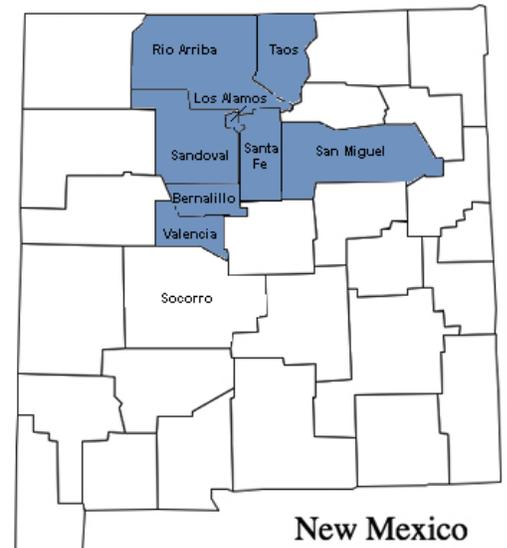
Figure 1: Buildings in eight counties in the state of New Mexico were assessed using the RVS method
